# Appendix 11.2: Outline Cliff Reinstatement Plan

# 1 Outline Cliff Reinstatement Plan

This reinstatement plan forms part of a Biodiversity Action Plan (BAP) for the Russian Landfall section of the South Stream Project. **Chapter 11 Terrestrial Ecology** identified that impacts to natural habitats occurred during the Design and Development phase of the Project. This document should be used as guide to inform the production of a detailed cliff-reinstatement plan, which will contain prescriptive measures to reinstate habitats within the affected area<sup>1</sup>.

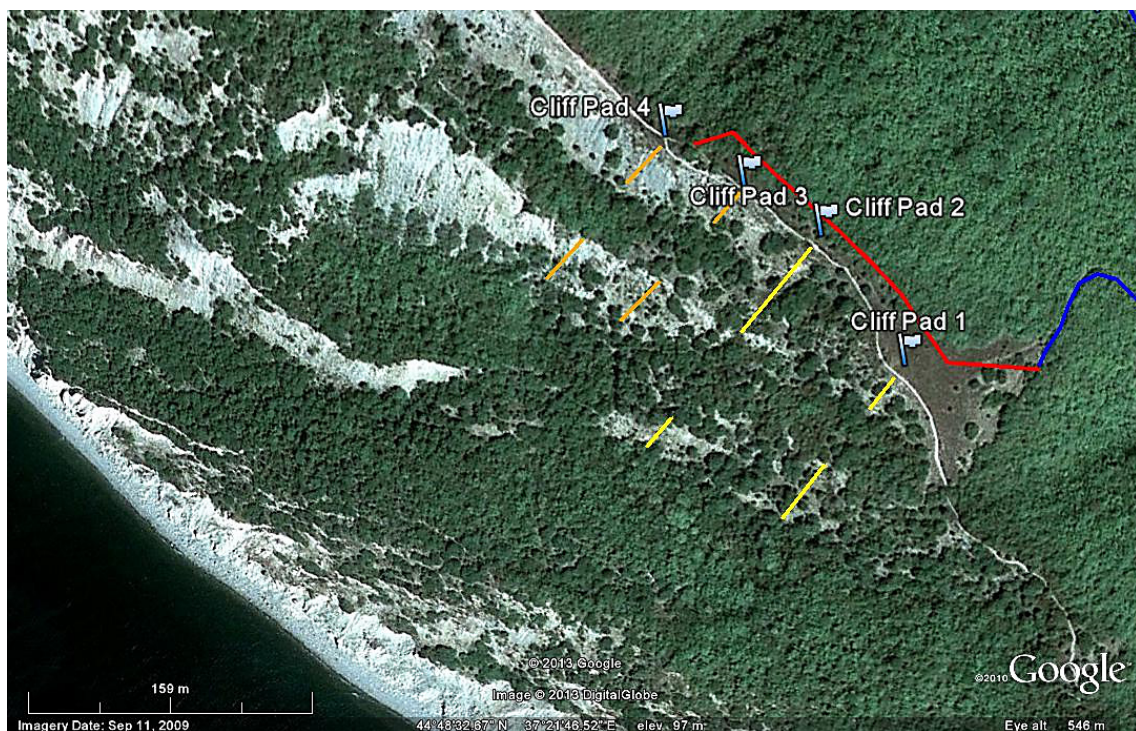
**Figure 2 Aerial Photograph showing cliff vegetation prior to clearance**

Legend: Yellow line for bank stabilisation with GEOJUTE and brush bundles, Orange line for bank stabilisation with brush bundles only.

On steep sections of cliff (below cliff pads 1 and 2, marked yellow on Figure 2) a biodegradable erosion control product, such as GEOJUTE (see Annex A), will be installed to control erosion and

To further reduce erosion and encourage the accretion of silt and topsoil, it is recommended that brush bundles are created from the juniper arisings which were left behind after the geotechnical clearance works. The bundles should be created by tying together cut trees and branches to form 20-30 mm wide and between 1-2 m long bundles. The specific dimensions should be varied according to fit the specific ground conditions at the fixing point. Each bundle should be secured (with the use of pins / pegs) across the slope of the cleared strip, at a shallow angle which will direct surface flow of water away from centre of the strip and into the areas of surrounding vegetation. Bundles should primarily be located in areas already subject to soil erosion. If necessary, soil and other surface material that has already been eroded may require relocating behind the installed bundles to reinstate the original slope profile. This should be completed on all strips including those below cliff-top pads 3 and 4 (marked orange on Figure 2).

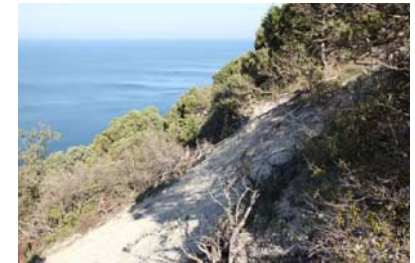
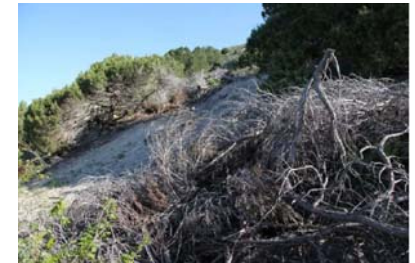
## Vegetation Reinstatement

1. Geojute laid and installed to manufacturer's recommendations to cover area to be reinstated.
2. Slits (150mm wide maximum) cut in geojute at appropriate centres to achieve re-vegetation to match existing vegetation density.
3. Planting pits to be prepared in accordance with specification at each slit location.
4. Juniper seedlings (plants to be of local provenance) planted through slits.

Annex B provides a schematic plan presenting the proposed stabilisation and re-vegetation strategy.
